Citation: Castori, Giulio, Borri, Antonio, De Maria, Alessandro, Corradi, Marco and Sisti, Romina (2017) Seismic vulnerability assessment of a monumental masonry building. *Engineering Structures*, 136. pp. 454-465. ISSN 0141-0296

# SEISMIC VULNERABILITY ASSESSMENT OF A MONUMENTAL MASONRY BUILDING

**Abstract.** *The seismic assessment of monumental buildings requires the consideration of safety and conservation objectives, both for the building and its cultural heritage assets. In order to face these issues, the paper presents the results of a diagnostic analysis carried out on a specific monumental masonry building: the Civic Museum of the small city of Sansepolcro in Tuscany. The building is one of the most important and renowned civic structures, built by a mediaeval Commune to house the town government, this building is also characterized by the presence of one of the masterpieces of late 15th-Century Renaissance art: "the Resurrection", a large fresco painted by Piero della Francesca. Within this context, three modelling strategies of different complexity are proposed: equivalent frame model, rigid macro-block model and finite element model. In the first part, a full three-d

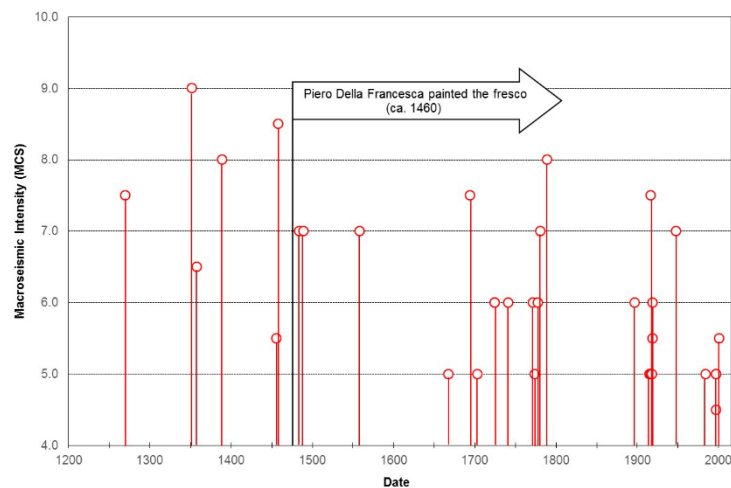
**Figure 3:** Historical macroseismic intensity (MCS) of the major events near Sansepolcro since 1200.

Even if Sansepolcro did not experience any devastating earthquakes in the past, an evaluation of the of historical seismic activity in such area [18] shows how the Civic Museum was exposed to an earthquake of degree 9 in the Mercalli-Cancani-Sieberg (MCS) scale in the past and to seismic events stronger than magnitude 7 (MCS scale) at least three times since the Piero Della Francesca’s fresco was painted (Figure 3).

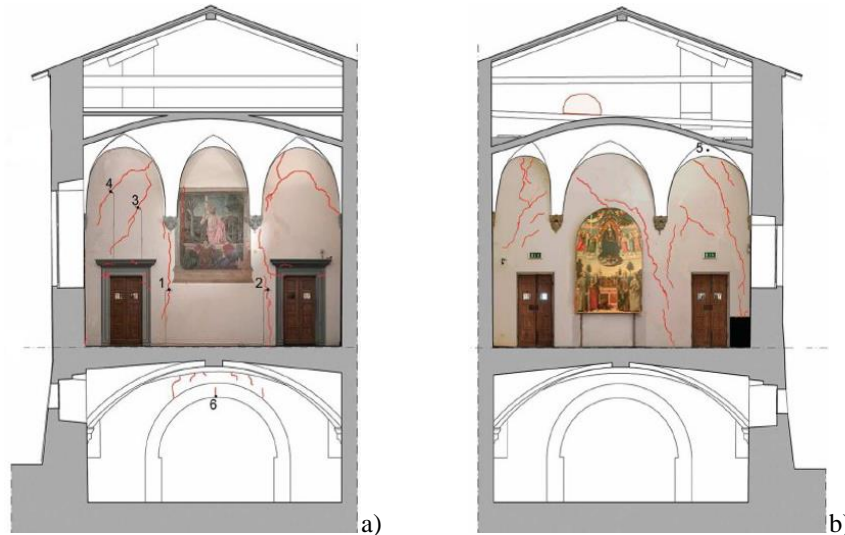
**Figure 5:** Cracking pattern of the wall containing the fresco (courtesy of Prof. C. Blasi): a) front view; b) rear view.

The crack pattern of the construction is quite complex: since no or little coupling effect can be operated by the horizontal (flexible) floors, vertical structures (walls) tend, in fact, to behave independently. Damage seems to localize maximally in correspondence of the longitudinal façades, north and south (Figure 4), being massive structures presenting significant heights and lack of transversal walls as bracing elements. It is possible to note that on the southern façade there is a relevant out-of-plumb (of about 60 mm, based on a general estimate), as a consequence of an out-of-plane rocking displacements of the perimeter walls (with a limited detachment of the façade from the masonry structure). Under such conditions, the internal wall panel supporting the Piero Della Francesca's fresco, being the only shear resistant wall able to restrain the overturning motion of the southern façade, manifests a severe cracking pattern, characterized by a combined failure mode with vertical and diagonal cracks (Figure 5).

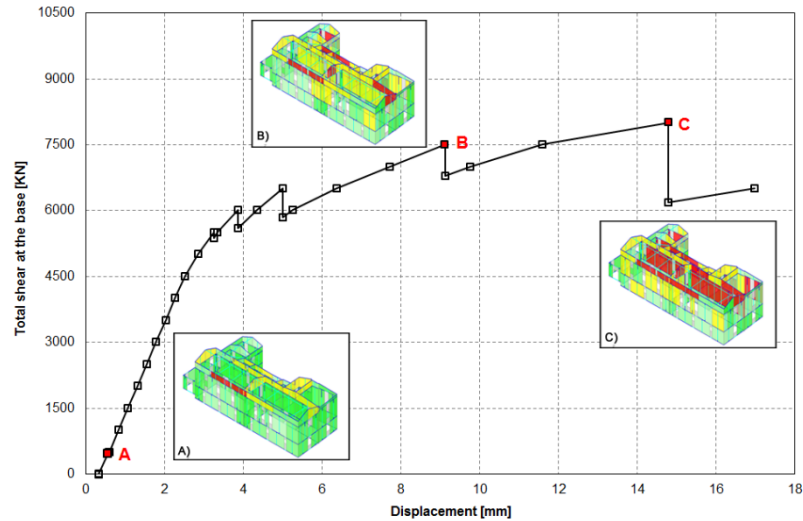
**Figure 8:** Capacity curve (maximum displacement vs total shear at the base) and failure progression sequence for the equivalent frame model in the y-direction.

The horizontal displacement of the structure's control node (placed in center of mass of the roof level) versus the corresponding total shear is reported in Figure 8. This diagram can be seen as the *capacity curve* of the structure in the transversal direction as it gives, among other information, the maximum seismic force that is bearable by the construction, i.e. the level of the Peak Ground Acceleration (PGA) needed for inducing the first failure mechanism.

Considering all the combinations and all the seismic directions requested by the Italian Code [12], the most severe loading condition was in the y-direction (-Y seismic action, Figure 9) for modal distribution and results (obtained by using the commercial software Aedes Pcm [25]) with respect to this case were studied in detail. In this direction, the three-dimensional strength of the structure is low and insufficient (40% lower than that related to the X seismic action), as a result of the progression of the out-of-plane bending failure of the orthogonal bearing walls (see point A, B and C of the capacity curve, Figure 8). This can be motivated on one hand by the presence of few bearing walls in the transversal direction (y-direction), and on the other hand by the fact that dead loads on floors were mainly distributed to walls parallel to the longitudinal direction (x-direction).
