Citation: Borri, Antonio, Sisti, Romina, Corradi, Marco and Giannantoni, Andrea (2016) Experimental analysis of masonry ring beams reinforced with composite materials. In: 16th IB2MAC - International Brick and Block Masonry Conference 2016, 26th - 30th June 2016, Padua, Italy.

Experimental analysis of masonry ring beams reinforced with composite materials

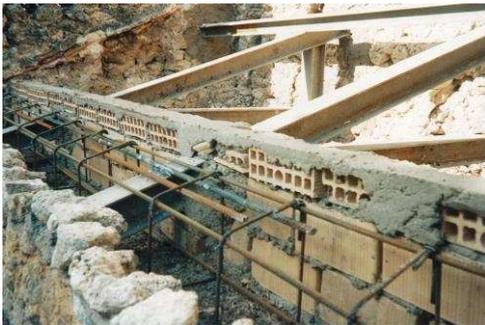
Figure 1. Example of a RC ring-beam.

In the past, improvement has been achieved by tie rod or ring beams and, in older buildings, it is possible to observe wooden ties and connectors inside masonry. In recent years wood ring beams have been replaced with RC (Reinforced Concrete) ring beam (Fig. 1) (Penazzi et al. 2001, D'Ayala et al. 2003, Alexandris et al. 2004); however recent earthquakes have shown the limitations of the later technique which prove to be ineffective when in-adequately designed, when not well connected to the existing masonry below, when built above poor masonry or when attached to a heavy floor.

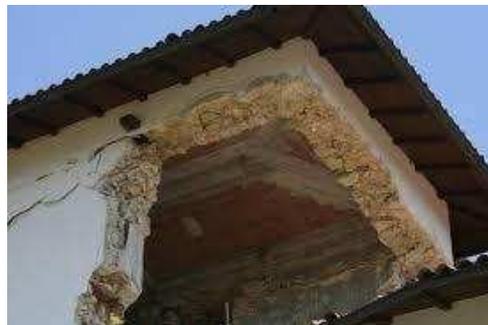
Figure 2. Example of an out-of-plane collapse due to poor connection between the RC ring beam and the underlying masonry.

It has been recognized by now that the greater stiffness of the RC ring beam compared to the stiffness of the masonry, produces a different response in these two materials during earthquakes and causes the load to be unevenly spread. In order to prevent out-of-plane collapse mechanisms, the action of vertical static loads may contribute to stabilize wall panels, but the application of stiff RC ring beam may cause the re-distribution of vertical compressive stresses and some portions of masonry could result unloaded and, during earthquakes, be prone to become unstable (Fig. 2) (Binda et al. 1999, Furukawa 2009, Magenes et al. 2014).

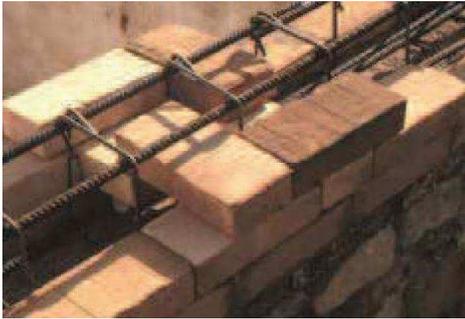
Figure 3. Example of a brickwork steel-reinforced ring-beam.

Nowadays, it's usual to apply steel-profiles or masonry ring beams (Figs. 3-4). However, when a building is faced with stone, the ring beams are made thinner than the wall so that they are screened

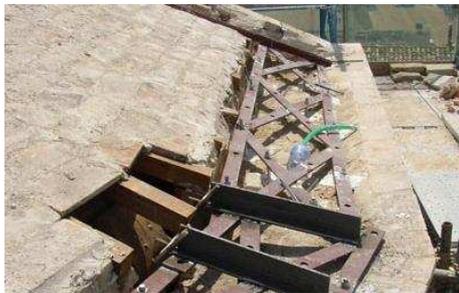
Figure 4. Example of a steel-profile ring-beam.

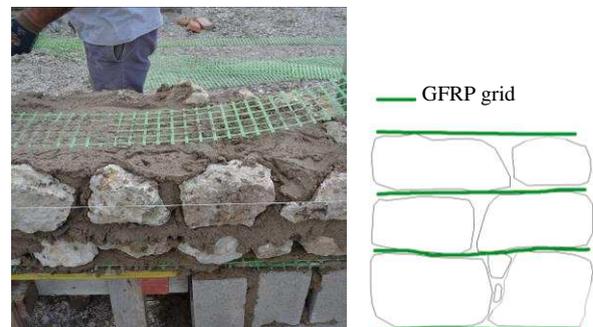
Figure 10. Construction of stone ring-beam strengthened with GFRP grids.

Four stone beams were built inserting a GFRP grid, made of AR (Alkali-Resistant) glass fiber with zirconium content equal to or over 16%, and of thermosetting epoxy vinyl ester resin. A rigid square meshes sized 33x33 mm were used in samples P5 and P6, whereas dimensions of 66x66 mm were employed in the P7 and P8 samples (Fig. 10).

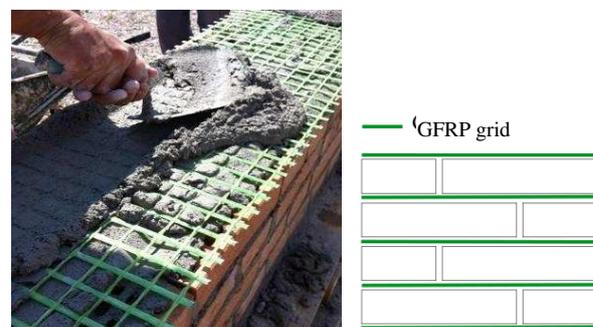
Figure 11. Construction of brickwork ring-beam using a GFRP grid.

The remaining two samples were made of brickwork masonry. Their length were the same as the other specimens (5 m) whereas the cross-section was 0.4 x 0.33 m and they were formed by 4 courses of bricks and mortar and 5 layers of reinforcement (Fig. 11). The mortar used in their construction was a ready-to-use cement-based mortar (denomination: M15).

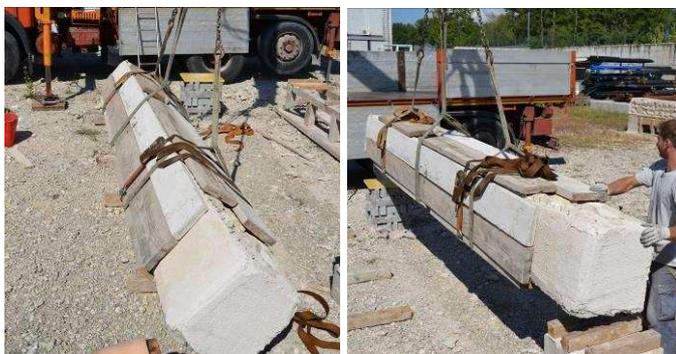
Figure 13. Rotation of a beam which were tested in horizontal plane.

In order to bend the beams in their horizontal plane and simulate the seismic action, some specimens were confined with wooden planks and web-bings clamped with ratchets and then were rotated 90° (Fig. 13). After this rotation the load was spread on the upper surface.

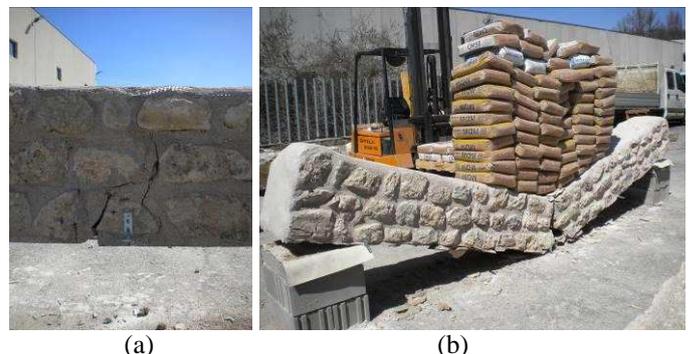
Figure 14. (a) Crack pattern produced by gravity self-weight load. (b) Ring-beam No. P3-U-V after testing.

In P2-T-H, P3-U-V and P4-UH specimens, one or two cracks appeared in the middle part of the ring-beams as result of self-weight loads when the wooden scaffoldings were dismantled. Looking into the cracks, it could be observed the breaking of the glass fiber sheet, whereas the PBO cords were not damaged (Fig. 14a). The cracking also indicate the transition from an elastic behavior (in which all the reinforcing materials collaborate) to a plastic one (in which just the PBO cords provided the tensile strength). After the failure of the glass-fibre sheet, the load was applied in order to analyze the beam's plastic behavior. In all the three cases the deflection of the beam increased considerably until it leaned on

ground; however the failure of PBO cords was never reached (Fig. 14b).
