Citation: Reeves, Christopher (2016) Policy for conservation of heritage railway signal boxes in Great Britain. *The Historic Environment: Policy and Practice*, 7 (1). pp. 43-59. ISSN 1756-7505

# **Policy for conservation of heritage railway signal boxes in Great Britain**

Christopher D. Reeves

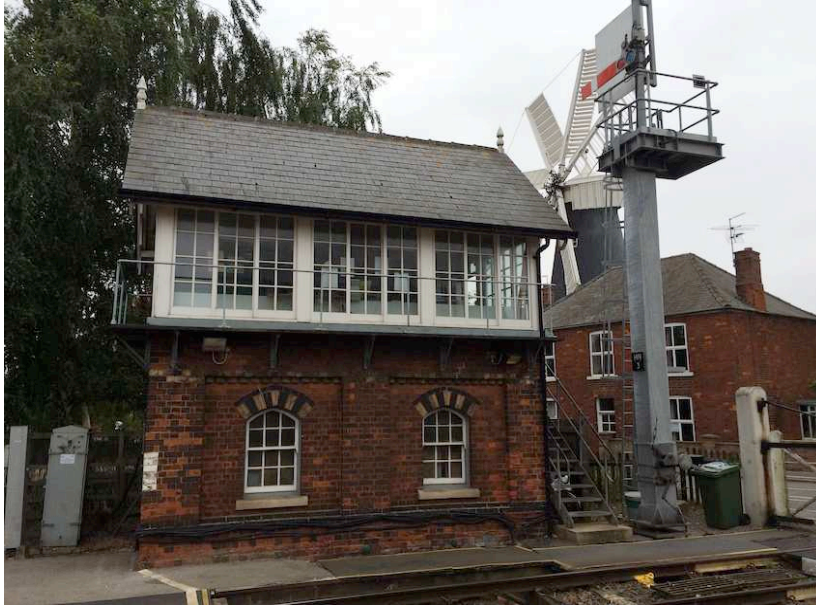
Figure 1: Heckington Signal Box (1876). This grade II signal box, with adjacent grade I windmill, almost represents an idealised English village environment. In this idealised world, the modern signal post is intrusive.

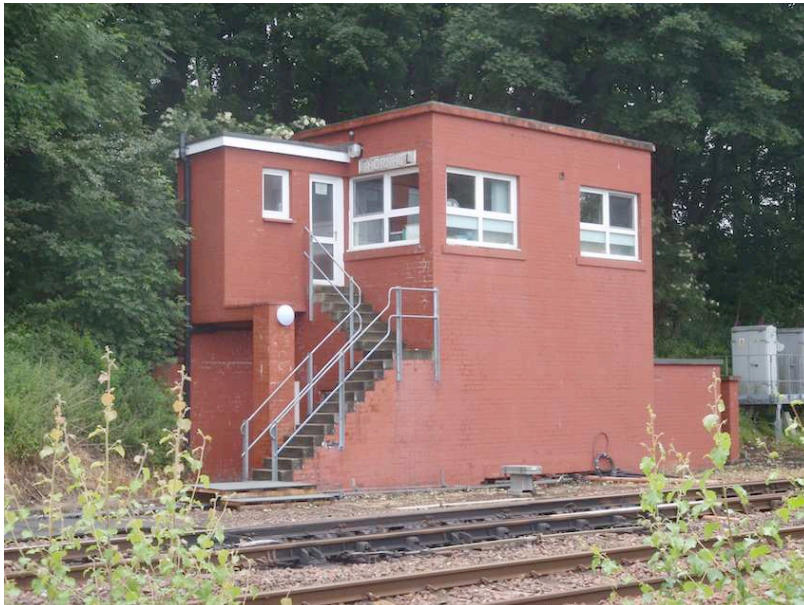
Figure 2: Thornhill Signal Box (1943). This signal box is an example of the austere designs for this era. The toilet facilities to the left are a later addition.  
© Christopher Reeves

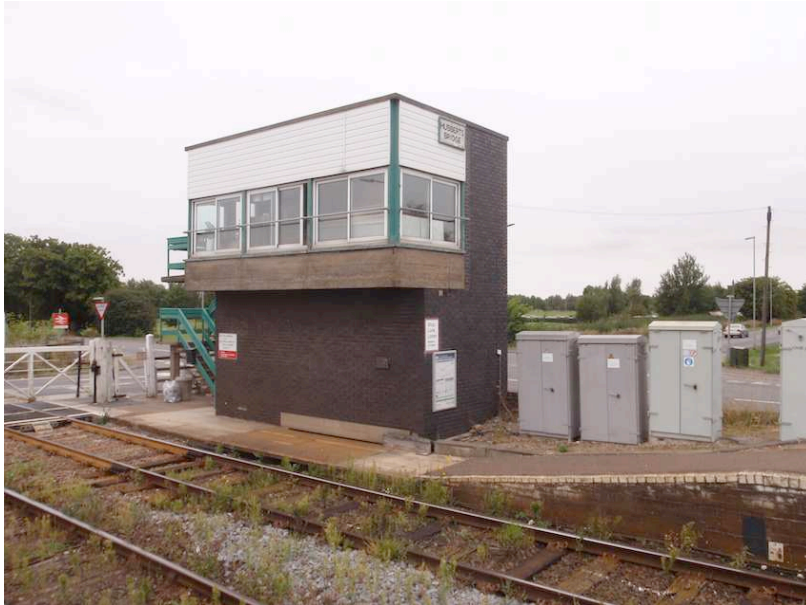
Figure 3: Hubberts Bridge Signal Box (1961). Possibly representing nearly the nadir of signal box design, this signal box is actually the next signal box along the line from Heckington. As an example of the era, arguably it is as worthy of preservation as it's prettier neighbour.

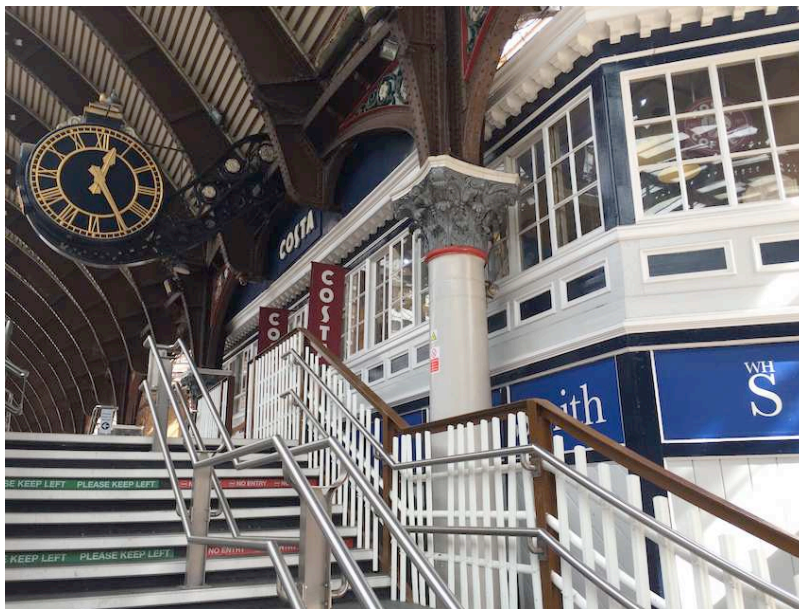
Figure 4a: York Platform Signal Box, operating floor (1907). With easy access from public circulation area by direct access from the footbridge, the operating floor of this signal box is in prime location for a café.

An example of retail use is the former Platform Signal Box at York, listed Grade II\* as part of the station group listing. The former operating floor is at one end of the footbridge and the entire structure occupies a central location opposite the main station entrance, so both levels are within main passenger circulation areas. It is clear that the successful reuse of this former signal box, having a café on the operating floor (Figure 4a)<sup>52</sup> and a retail outlet occupying the locking room (Figure 4b), is entirely due to a prime location for commercial use.

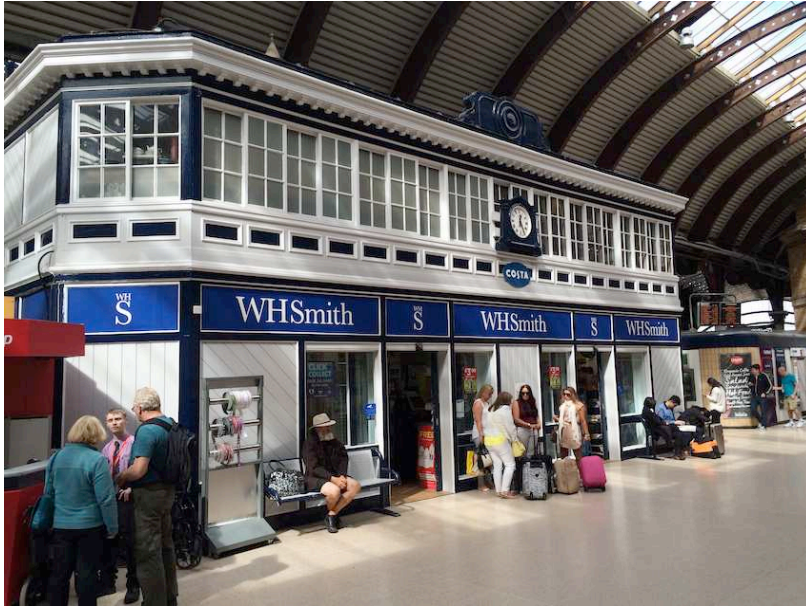
Figure 4b: York Platform Signal Box, rear elevation (1907). This rear elevation view illustrates how the locking room has become a retail unit within this circulation area for the station entrance. It is questionable how many of the station users in this illustration are aware that the retail unit and café was originally a signal box.

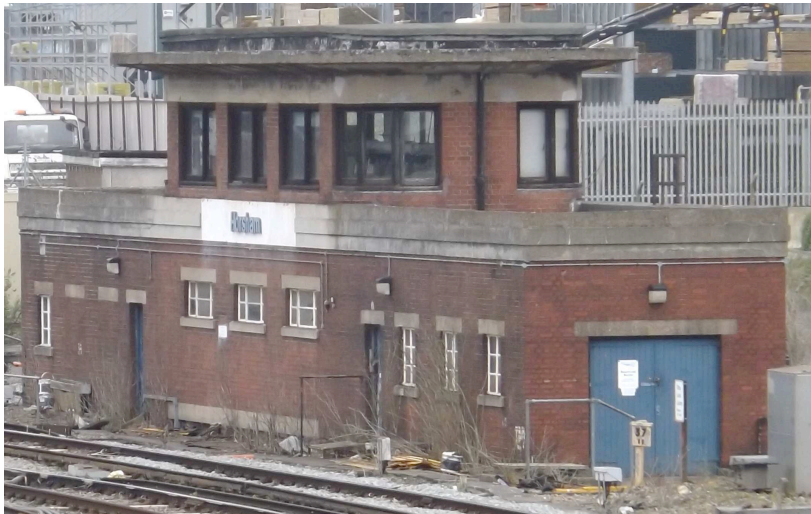
Figure 5: Horsham Signal Box (1938). The Southern Railway 'Type 13' signal box in International Modern style represents a conscious attempt at an attractive, modern design for interwar era signal boxes.

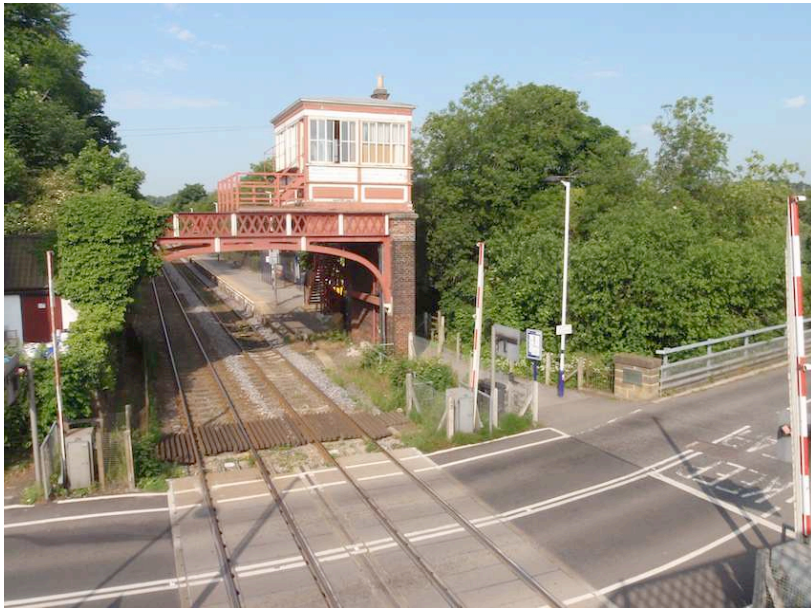
Figure 6: Wylam Signal Box (1897). This signal box is one of only three surviving UK over track designs. Notice the difficult access hindering any alternative reuse for this attractively situated signal box. Wylam, now a commuter village for Newcastle, has a strong connection with early railway history.

The 'Wylam question' is an unanswerable question defining the situation for many surviving signal boxes. Constructed circa 1897<sup>63</sup> by adapting a standard North Eastern Railway design to an over-track configuration, the signal box at Wylam in Northumberland is an unusual, esteemed structure in an attractive location. It is Grade II listed, yet effectively a wooden hut on an iron structure over a busy railway and thereby seemingly pointless other than as signal box (Figure 6). Even mothballing after the projected closure in 2020<sup>64</sup> carries problems, as the iron structure will be too close to power lines when planned electrification finally happens. Significantly, the listing does not mention an attractive riverside location or, should relocation be a possibility, that the articulate residents of Wylam will most likely have, I would expect following the precedent of Deeping Saint James, a vigorous opinion.
