The hydraulic characteristics of Roman lead water pipes: an experimental investigation

Abstract

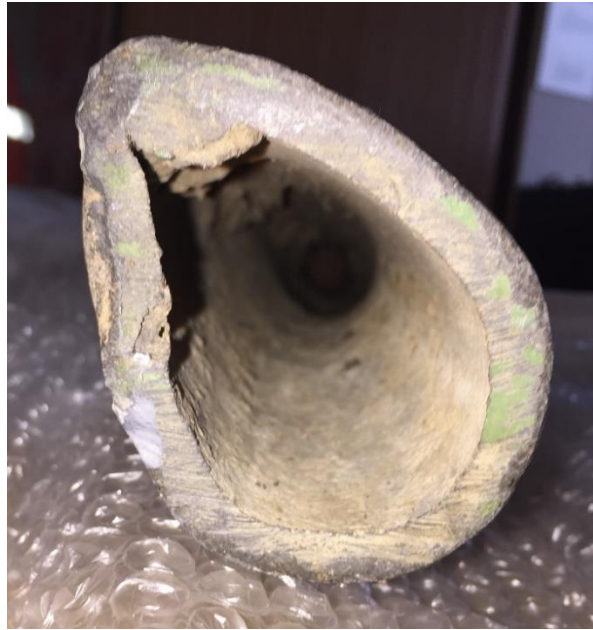
Figure 1: Example of a Roman lead water pipe formed from a sheet of metal with a soldered joint at the top. The pipe internal dimensions are 76 x 43 mm

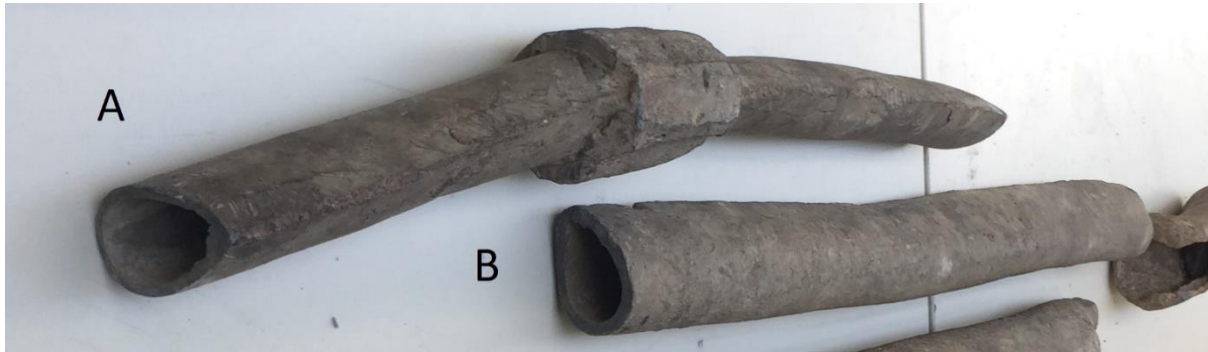
Figure 2: The two pipe sections tested: A - jointed pipe and B - non-jointed pipe. Both are sections from the same run of pipe at Red House Baths, Corbridge. The pipe sections shown are all approximately 1 m in length

Two broadly similar sections of pipe were considered, each approximately 1 m in length (Figure 2). These were both sections of the same 18.52 m length of pipe excavated and reported by (Daniels 1959). One section has a sleeve joint in its centre; the other does not. This gave the potential for examining the hydraulic significance of the joint as well as the pipe itself, by comparing the performance of the two specimens under similar conditions.

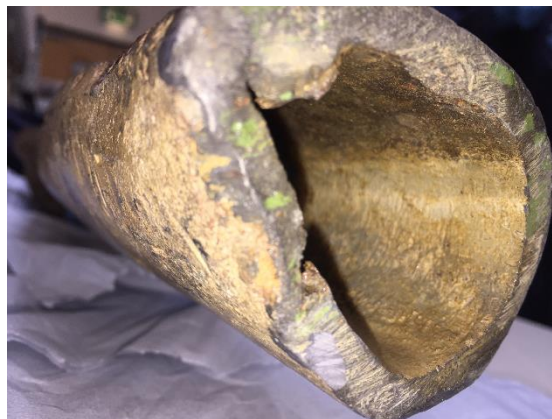
Figure 4: Distinctive sinter line observable in pipe. This indicates a substantial pattern of partially-full flow

A further feature of note is that the pipes had a noticeable deposit of sinter (limestone) over the lower part of their section, as shown in Figure 4. The distinctive ‘tide line’ at the top of this deposit is parallel to the pipe, indicating that it arose from the flowing partially full, leading to the sinter deposit on the lower, wetted section of the pipe, but not on the drier, top part. Had the sinter formed from standing water following the baths falling into disuse, the tide line would have been horizontal rather than parallel to the pipe; in any case, sinter precipitation is the result of degassing of CO₂ from the water, a process which is enhanced by turbulence and much more likely to occur in flowing than in standing water (Buhmann and Dreybrodt 1985, Sürmelihindi, Passchier et al. 2013). Partially full flow suggests that that the soldered joint may not have been wetted all that often, and so would have had little effect on the actual operation of the pipeline. The gradual build-up of sinter would, of course, have affected the hydraulic performance somewhat over time, changing the wall roughness.

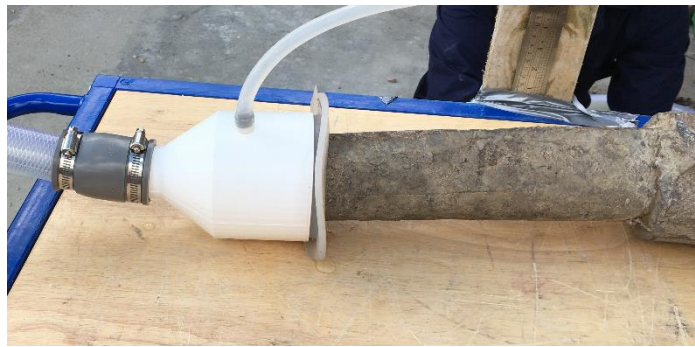
Figure 5: The 3D-printed connector and pressure measuring arrangement: (a) side view; (b) end view; (c) in situ on pipe

The pipes were linked to the experimental rig by means of 3D-printed connectors (Figure 5). These were based on the scans, which were used to create a 3D digital replica of each pipe end, and from these, individual slices were made to create 2D CAD drawings. The drawn cross-sections were decreased to 96% of their original size to ensure a tight seal and used to create plywood moulds for the casting of sealing pieces, using ECOFLEX silicon two-part mix. This created a soft seal on the outside of the pipes, where it would not interfere hydraulically or cause damage to the ancient artefacts. The soft seals were held in outer connectors that were drawn in SolidWorks and 3D-printed in PLA. These connected to the experimental pipework by means of jubilee clips. The connectors were fitted with L-shaped static tubes (Figure 5 and Figure 6), again drawn in SolidWorks and 3D-printed in Formlabs clear resin. These allowed static pressure measurements within the Roman pipe, having their end facing the flow capped off, but a series of pressure tapping holes around their circumference, normal to the direction of flow. The longitudinal length of the tube between the point where it emerged from the side of the connector and the static pressure tappings was 100 mm, and when connected to the pipe the pressure measurement point was around 60 mm away from the end of the lead; this was considered a reasonable distance away from the junction with the connector to avoid hydraulic effects of the joint, bearing in mind the already quite short length of the whole section of pipe. The connector and pressure tapping arrangement is shown in Figure 5. The effective length of each pipe section under test was therefore the measured distance between the centre lines of the static tube where they emerged from the side of the connectors, less 2 x 100 mm to allow for the L-piece at the pipe centre line.

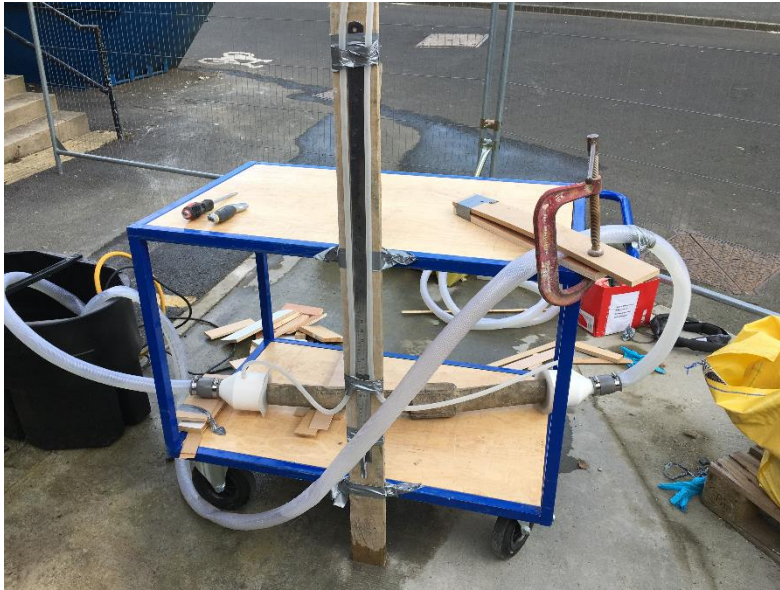
Figure 6: Overview of the experimental rig showing the jointed pipe under test, with manometer and flow control. To the left is the sump tank in which the pump was located

Flow was controlled by means of a G-clamp compressing the flexible hose attached to the pump (Figure 6); this simple arrangement allowed quite fine control. Flow was measured by recording the time taken to fill a 30 litre container, averaged over at least two similar readings. The static pressure difference between each end of the pipe section was measured using a simple manometer arrangement with a metre rule and flexible tubes taped securely in place (Figure 6). At the start of each test, air was carefully expelled from the manometer tubes, and the manometer reading was photographed three times to avoid difficulties in reading it caused by small water level fluctuations; the average reading was taken from three photographs.

A full view of the experimental arrangement is shown in Figure 6.

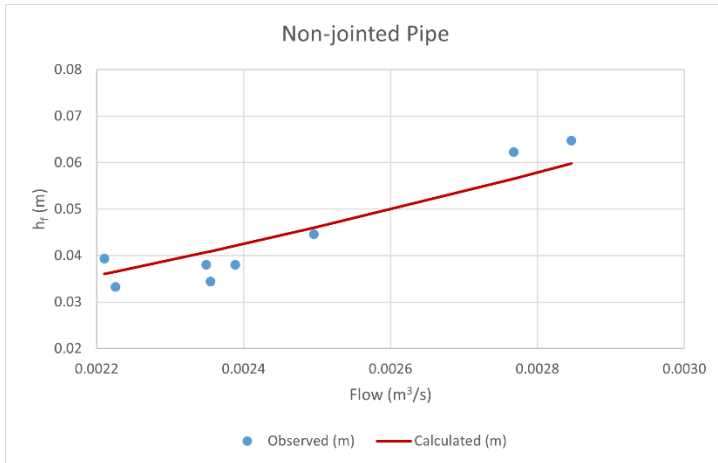
Figure 8: Observed and calculated head loss against flow for Non-jointed Pipe. Calculated values use the Darcy-Weisbach and Colebrook-White Equations, with $k_s = 0.9 \text{ mm}$

Taking the non-jointed pipe section, it was assumed that all head loss over the test resulted from pipe friction loss as given by equations (1) and (2), and a curve fit was carried out to the experimental results, varying k_s until the best fit in terms of the minimum sum of residuals squared was obtained, residuals being the difference between the calculated head loss for the observed flow, and the observed head loss. This gave a fit with a correlation coefficient of 0.961 corresponding to a k_s value of 0.9 mm, which is indicative of a rough pipe. To put this in context, a value commonly used for a modern concrete pipe is 1.5 mm, and that for a PDPE pipe is typically 0.03 mm.

A plot of the curve-fit is shown in

. Whilst the raising of the velocity to the power of two in equation (1) arises from dimensional analysis, it is clear that in order to gain an exact fit to the observed data, a higher power is required. In fact, using a power of 2.6 gives a much better fit at higher flow values, whilst not making dimensional sense. Varying this power would also offer no help in any subsequent use of the information in network modelling using typical application software, where use of the established pipe-flow equations is mandated and only parameters such as k_s or D can easily be changed.
