3rd International Conference on
**Transdisciplinary Multispectral
Modelling and Cooperation
for the Preservation of Cultural Heritage**
Recapturing the World in Conflict through Culture
promoting mutual understanding and Peace

eProceedings

The out-of-plane behaviour of wall panels reinforced with Titanium rods

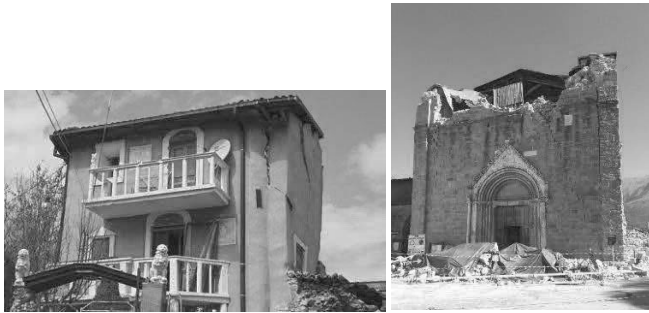
Fig. 2. Examples of out-of-plane collapse mechanisms of masonry buildings.

One of the most dangerous failure modes of masonry structures is the rocking (out-of-plane) mechanism of a load bearing wall. Its activation could easily lead to the collapse of a whole masonry building due to the domino effects (Figs. 1 and 2). In fact, the rocking collapse of a single wall can cause a series of related collapse events, one following another, of the structural members of a building. To avoid the out-of-plane
