## Use of natural resins in repairing damaged timber beams – An experimental investigation

A I Osofero<sup>1\*</sup>, M Corradi<sup>2</sup>, G Benedetti<sup>2</sup> and A N Ede<sup>3</sup>

**Abstract.** Different techniques including the application of steel elements, composite materials and polymeric resins have been used in the past to repair damaged timber beams. However, there is a growing need to replace these materials with those with minimal environmental impact. In addition, stringent requirements of conservation authorities on the compatibility between repair and parent materials have also necessitated search for innovative repair materials for timber beams. Therefore, an increasing shift of focus towards the use of materials derived from natural sources in repairing and reinforcing timber structures is currently experienced. This paper presents the results of an exploratory study on the use of natural resins (rosin and bone glue) in repairing oak timber beams. 15 oak timber beams with cross section dimensions of 67 x 67 mm and 1100 mm in length were tested in four-point bending to failure. Undamaged, damaged (unrepaired) and damaged but repaired timber beams (with rosin

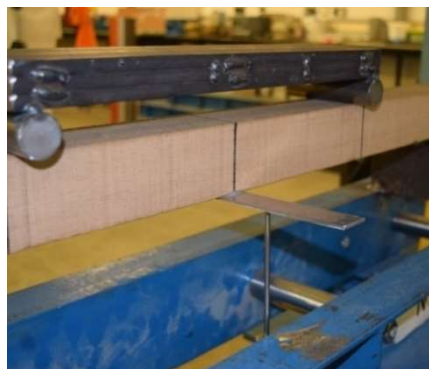
Linear Variable Displacement Transducer (LVDT) was used to measure maximum beam deflection (at mid-span) for every load increase as shown in figure 2. To attach the LVDT, a steel plate was glued to the tension side of the beam at the mid-span and the transducer sensor was set up such that it just touches the underside of the steel plate. The Instron machine and the linear transducer were then synchronized to ensure corresponding output at a frequency of 1 Hz were obtained.

**Figure 2.** Measurement of vertical deflection at mid-span using LVDT.

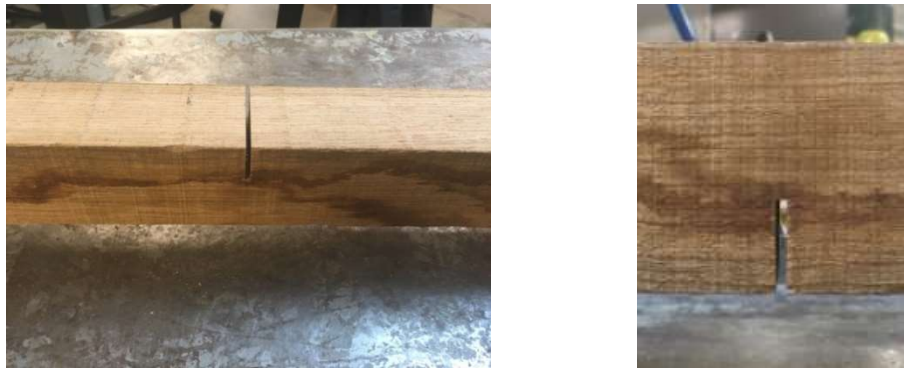
**Figure 3.** Damaged beam specimens (cut dimensions: 20 x 67 mm).

A total number of 15 small timber beams were tested in four-point bending. The timber beams were from European Oak (D30) with nominal dimensions of 67 x 67 x 1100 mm and approximate density of 670 kg/m<sup>3</sup>. Applied load and mid span displacement at failure were measured and recorded. Prior to testing, the beams were numbered, measured, weighed. The moisture content of each beam was also measured (table 1). Subsequently, controlled damage, represented by a machined cut of 2.85 mm thickness and 20 mm height were introduced in 12 of the beam specimens (figure 3), while the remaining three were used as control specimens.
