Citation: Righetti, Luca, Corradi, Marco and Borri, Antonio (2015) Basalt FRP Spike Repairing of Wood Beams. *Fibers*, 3 (3). pp. 323-337. ISSN 2079-6439

Basalt FRP Spike Repairing of Wood Beams

Luca Righetti ^{1,*}, Marco Corradi ^{1,2} and Antonio Borri ²

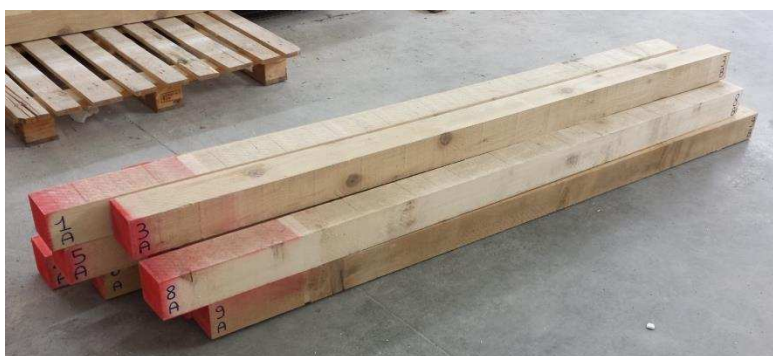
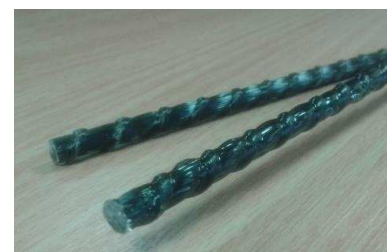
Figure 4. (a) Softwood beams; (b) BFRP spikes.

All beams were made of softwood (fir-wood). Tests were carried out on sharp-edged timber beams (Figure 4a) in fir wood (*Abies Alba*). All the timber beams had the same width (96 mm), height (96 mm) and length (2000 mm). The average weight density and moisture content were 417 kg/m³ (dev. 24 kg/m³) and 14.31% (dev. 0.89%), respectively. Moisture content was measured according to EN 13183-1: 2002 standard [27].

Due to its anisotropic behavior, seasoning of timber always causes split opening along the grain in structural timber beams. The prime objective of seasoning is to reduce the moisture content and increase mechanical properties. BFRP spikes (Figure 4b) were used here to restore the continuity of artificially damaged timber beams.

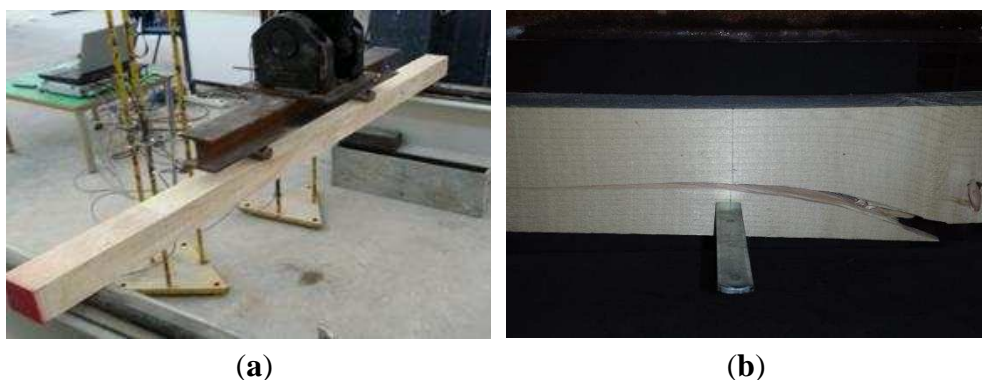
Figure 5. (a) Four-point-bending test setup; (b) Typical tensile failure mode of control beams near a knot or due to grain deviation.

where l is the distance between the rollers; $F_2 - F_1$ is an increment of load on the straight-line portion of the load deformation curve; $w_2 - w_1$ is the increment of deformation corresponding to $F_2 - F_1$; b is width of cross section. In order to have a overall information of the stiffness properties of the timber beams it was decided to measure and calculate only the global modulus of elasticity evaluated according to Equation (11). The test setup is shown in detail in Figure 5a.

Fourteen control beams were subjected to flexure in four-point-bending. These results have been reported only for the purpose of quantitatively calculating the effectiveness of the repair intervention through a comparison with the results of identical tests performed on the strengthened beams. Various modes of fracture were detected in the timber beams, but all on the tension side: simple tension, cross grain tension, knot influenced (Figure 5b). Knots and grain deviation highly influenced the propagation of the cracks for all control specimens. Deflection characteristics of the tested control beams are shown in Table 4, the average bending strength was 24.5 MPa (dev. 8.3 MPa) and the global modulus of elasticity was 5932 MPa (dev. 907 MPa).

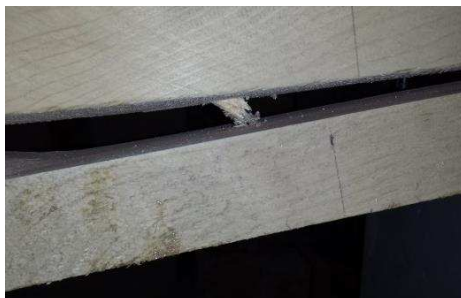
Figure 8. Pull out of the BFRP spike.

The repaired cut-in-half beams (RS_1, RS_2, RS_3, RS_4 and RS_5) exhibited an average bending strength of 15.0 MPa and a global modulus of elasticity of 4904 MPa. Failure, again knot influenced, occurred in the timber material on the tension side where the bending moment is maximal. After timber failure, the BFRP spikes did not exhibit any damage, but partially separated from the epoxy resin in the holes. Slippage was also generated by timber shear failure near the holes caused by the low shear strength of fir wood (Figure 8). Figure 9 shows the load-deflection response of control and repaired beams that were cut in half. The load-displacement graphs generally show that there is a large amount of vertical mid-span deflection even for low loads due to the slippage of the BFRP spikes.

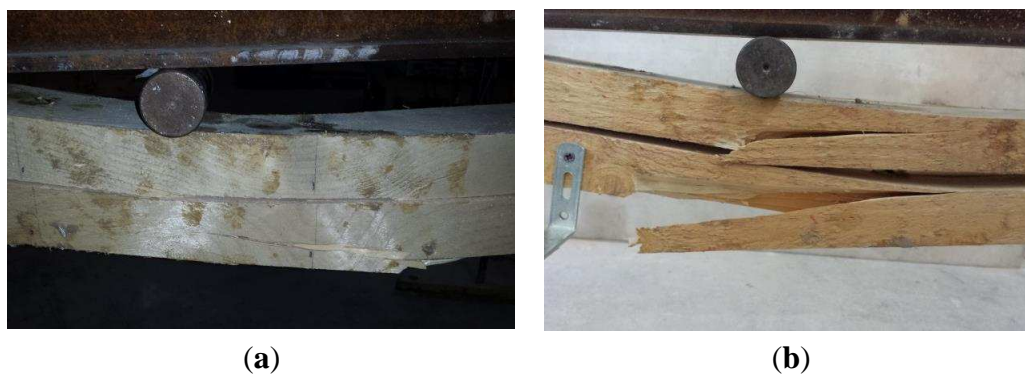
Figure 10. Timber tensile-flexural failures (beams that were cut in half): (a) in the lower half; (b) both in the lower and upper half.

Another interesting feature of the load-deflection curves is that repaired specimens after an initial decrease of the load due to a beam cracking, were able to withstand a further increase in load. The BFRP repaired beams demonstrated an initial linear elastic behavior and exhibited brittle timber tensile-flexural

failures on the lower half of the timber beam when subject to flexural loading. After this, a pseudo-ductile behaviour of the repaired beams has been recorded.
