7 **Basalt FRP spike repairing of wood beams**

8 **Luca Righetti**^{1,*}, **Marco Corradi**^{2,3} and **Antonio Borri**³

29 This paper describes an experimental study on the use of basalt FRP (BFRP) spikes into timber
30 beams to restore the continuity of cracked and damaged sections. The repair technique consists in the
31 application of 95 mm long BFRP spikes inserted into diagonal holes perforated in the timber beams at
32 centre-to-centre distance of 200 mm. An artificially simulated cracking was produced by cutting in half
33 and notching the wood beams. Repaired and control timber beams were carried out to four-point-
34 bending test and results in terms of bending capacity and modulus of elasticity were compared to
35 evaluate the effectiveness of the proposed repair technique. In comparison with the use of self-tapping
36 screws this procedure may be of interest because of the lower Young’s modulus of BFRP spikes
37 (similar the one of timber) and for lower stress concentration based on the larger dimensions of BFRP

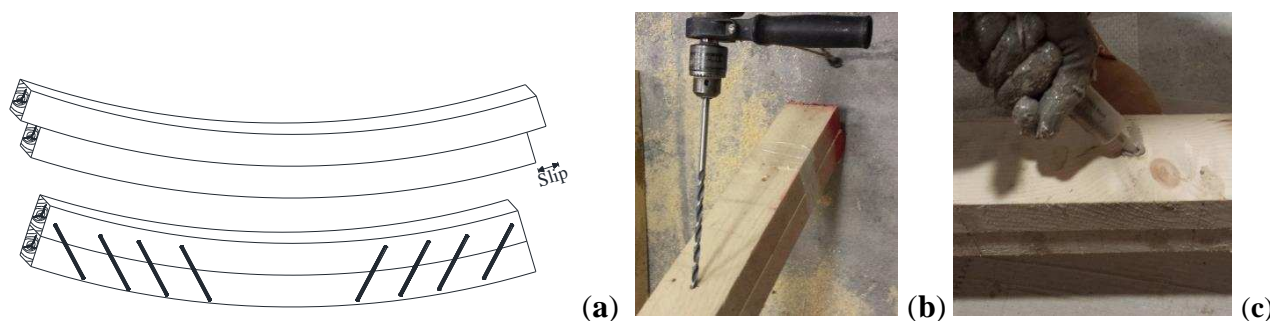
24 **Figure 1.** (a) Schematic arrangement of BFRP spikes; (b) Diagonal hole drilling, (c) Injection of epoxy putty.

12 In this investigation eight BFRP spikes were inserted into diagonal holes (45°) drilled in the timber
 13 beams (Figures 1b and 2) at a centre-to-centre distance of 200 mm. The use of inclined spikes was
 14 chosen because several experimental and numerical studies have showed how the increase of screw
 15 inclination affords an increase of the resistance and stiffness of the joints [23-24]. No spikes were
 16 applied in the central part of the softwood beams where shearing force equal to zero. Bi-component
 17 epoxy putty was injected inside the holes before inserting the BFRP spikes to facilitate the connection
 18 between timber and reinforcement (Figure 1c). By considering that the spike and hole diameters were
 19 6 and 8 mm, the epoxy bond thickness was approximately 1 mm.

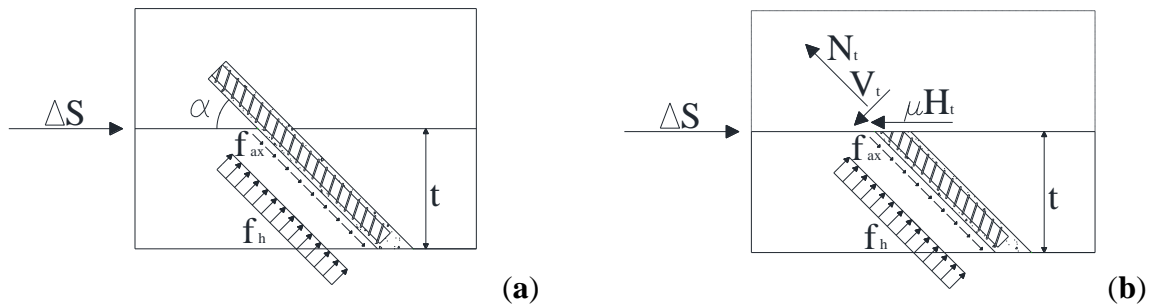
3
 4
 5 **Figure 3.** Failure mode A: (a) stresses in the joint; (b) load on the interface between the
 6 timber elements.

In order to calculate the diameter (d) of the spikes (Table 1), the Johansen yielding theory [25] has been used and adapted for this purpose. The Johansen approach identifies three different failure modes for timber to timber joints with connections: in the first mode (mode A), the final load-bearing capacity is obtained when the wood yields plastically along the reinforcement (Figure 3); the second (mode B) is characterized by a combination of the embedment failure in the timber and a single yield failure in

1 the connector. The last failure mode (mode C) occurs when is reach a combination of the embedment
 2 failure in the timber and a double yield failure in the connector.

7 Due to the high mechanical characteristics of the BFRP spikes and the loads reached on the tests
 8 carried out on the control beams the design of the nominal diameter has been evaluated considering
 9 only the failure mode A. The ultimate load-bearing capacity can be calculated from internal forces (Eq.
 10 1). The following equation is based on the equilibrium in the non-deformed state:

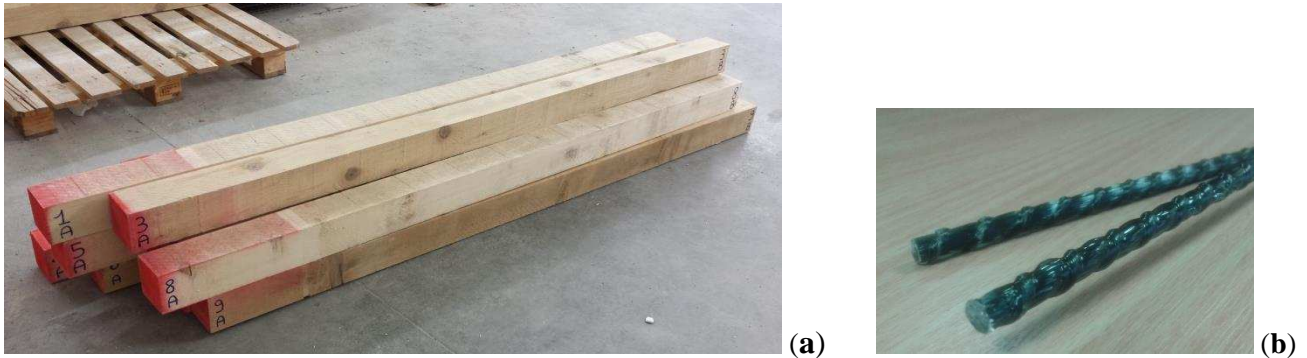
7 **Figure 4.** (a) Softwood beams; (b) BFRP spikes.

12 All beams were made of softwood (fir-wood). Tests were carried out on sharp-edged timber beams
13 (Figure 4a) in fir wood (*Abies Alba*). All the timber beams had the same width (96 mm), height (96
14 mm) and length (2000 mm). The average weight density and moisture content were 417 kg/m^3 (dev. 24
15 kg/m^3) and 14.31 % (dev. 0.89 %), respectively. Moisture content was measured according to EN
16 13183-1: 2002 standard [27].

18 Due to its anisotropic behaviour, seasoning of timber always causes split opening along the grain in
19 structural timber beams. The prime objective of seasoning is to reduce the moisture content and
20 increase mechanical properties. BFRP spikes (Figure 4b) were used here to restore the continuity of
21 artificially damaged timber beams.

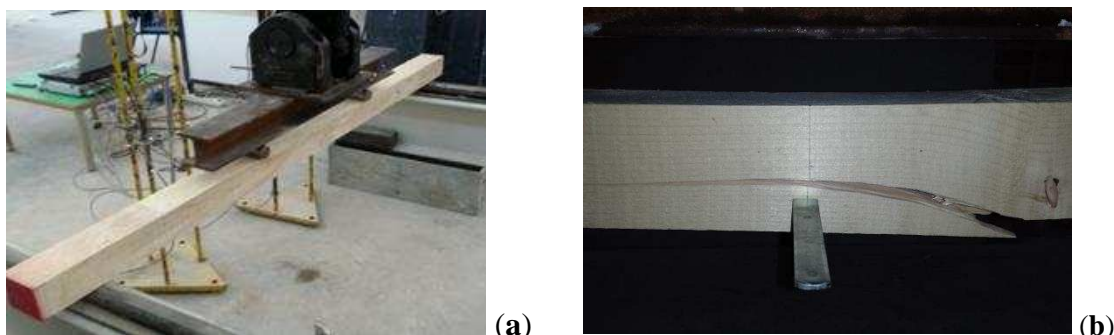
4
 5 **Figure 5.** (a) Four-point-bending test setup; (b) Typical tensile failure mode of control
 6 beams near a knot or due to grain deviation.

where l is the distance between the rollers; $F_2 - F_1$ is an increment of load on the straight-line portion of the load deformation curve; $w_2 - w_1$ is the increment of deformation corresponding to $F_2 - F_1$; b is width of cross section. In order to have a overall information of the stiffness properties of the timber beams it was decided to measure and calculate only the global modulus of elasticity evaluated according to [12]. The test setup is shown in detail in Figure 5a.

Fourteen control beams were subjected to flexure in four-point-bending. These results have been reported only for the purpose of quantitatively calculating the effectiveness of the repair intervention through a comparison with the results of identical tests performed on the strengthened beams. Various modes of fracture were detected in the timber beams, but all on the tension side: simple tension, cross grain tension, knot influenced (Figure 5b). Knots and grain deviation highly influenced the propagation

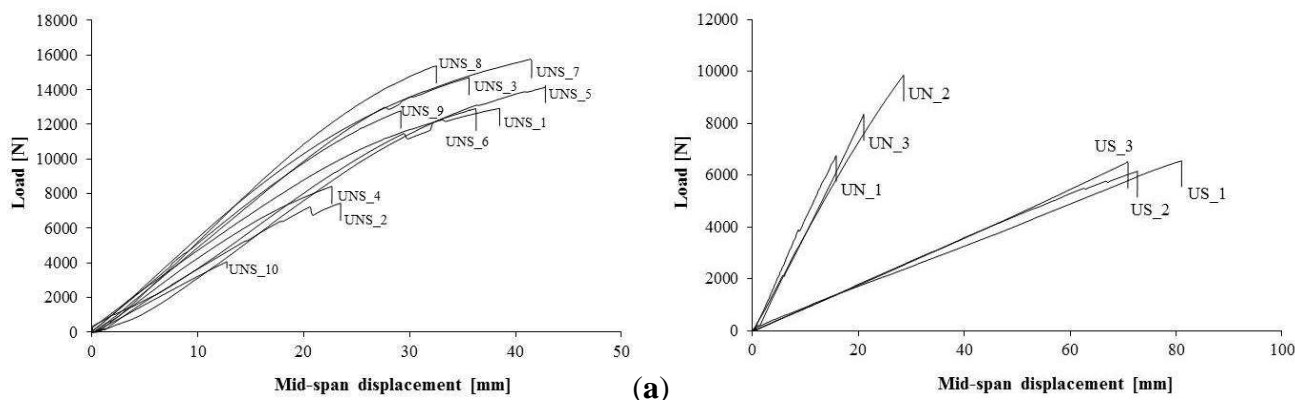
13
 14 (b)
 15 **Figure 6.** Load-Displacement curves: (a) control un-damaged beams;
 16 (b) cut in half and notched beams.

7 Load-displacement curves (Figure 6a) are initially linear. As the load increases, timber begin to
 8 yield in the compression zone and failure occurs in the tension zone when the tensile strength is
 9 reached. Three beams (UNS_2; UNS_4 and UNS_10) exhibited an early failure influenced by the
 10 presence of a large defect (knot) in the tension side (Figure 5b). The scatter in the capacity values of
 11 control beams, where the presence of grain deviation and knots influence the failure mode, is very
 12 high.

1 recorded during the tests. All the artificially damaged (cut in half and notched timber beams) usually
2 showed an elastic-linear response up to the failure (Figure 6b).

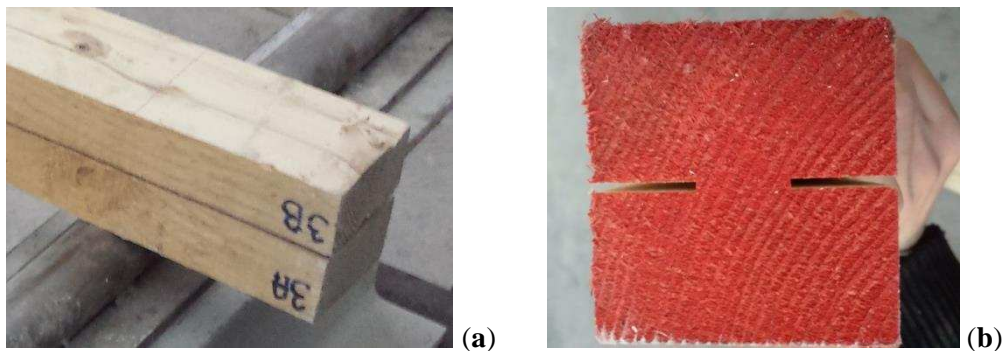
6 **Figure 7.** (a) Timber beams cut in half; (b) Notched beams.

17 Six beams were subjected to four-point-bending after being artificially damaged: three timber
 18 beams were divided in-half and three were cut with two 35 mm horizontal notches (Figure 7). The
 19 control notched specimens (UN_1, UN_2 and UN_3) exhibited an average bending strength of 16.66
 20 MPa and a global modulus of elasticity of 5622 MPa. Furthermore the failure of these specimens
 21 occurred in the area where bending moment is maximum. Fracture was influenced by the presence of
 22 the two notches: beams UN_1 and UN_3 failed due to separation of upper part half from lower half

5 BFRP spikes have been applied to cut-in-half (Figure 7a) and to notched beams (Figure 7b) with the
6 aim to restore the continuity of damaged timber beams.

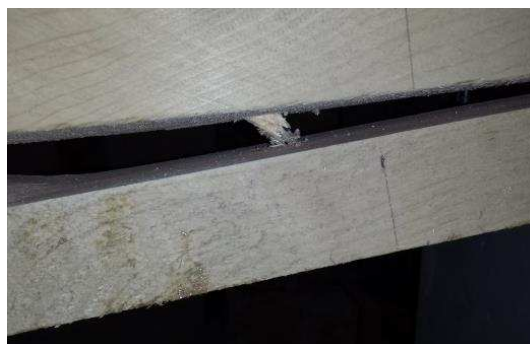
9
10 **Figure 8.** Pull out of the BFRP spike.

1 After an initial elastic phase, repaired beams (RS_series) exhibited a plastic behaviour. Increases of
 2 bending strength compared to control beams were limited due to low quality of timber material (fir
 3 wood) and separation of BFRP spikes from the epoxy resin. Beams RS_2 and RS_3 collapsed for a
 4 low bending load due the presence of a large knot defect in timber tension zone. The insertion of the
 5 BFRP spikes resulted in moderate enhancements in the beam ultimate capacity (+19.8 %) while more
 6 significant improvements in the stiffness were obtained (+325.7 %) and it is essentially due to the low
 7 values of stiffness of cut-in-half beams. However the insertion of the BFRP spikes did not cause the
 8 achievement of the values of the control timber beams in terms of bending capacity and stiffness.

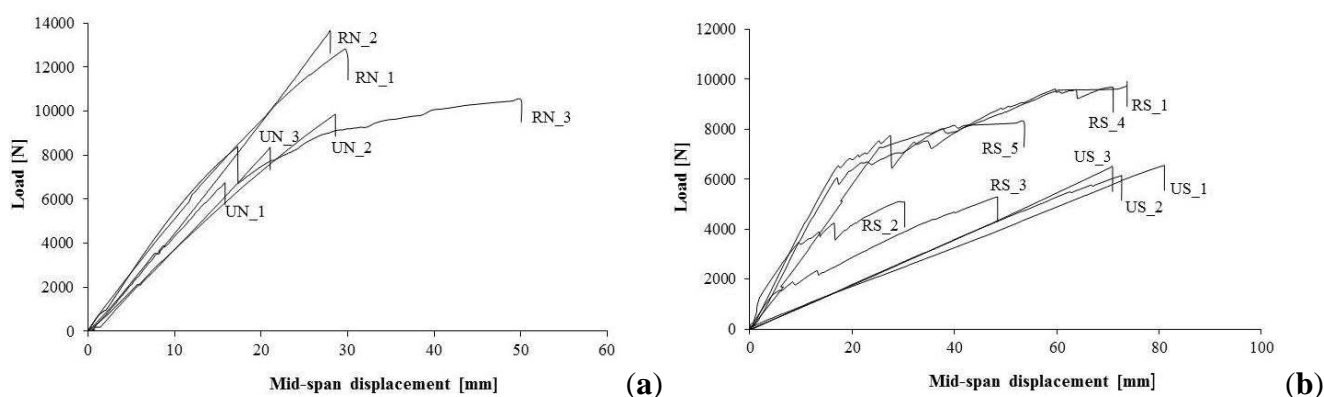
16
17 **Figure 9.** Load-Displacement curves: (a) control (US-series) and repaired (RS-series)
 18 beams cut in half, notched beams; (b) control (UN-series) and repaired (RN-series) beams
 19 cut in half.

11 Another interesting feature of the load-deflection curves is that repaired specimens after an initial
 12 decrease of the load due to a beam cracking, were able to withstand a further increase in load. The
 13 BFRP repaired beams demonstrated an initial linear elastic behaviour and exhibited brittle timber
 14 tensile-flexural failures on the lower half timber beam when subject to flexural loading. After this, a
 15 pseudo-ductile behaviour of the repaired beams has been recorded.

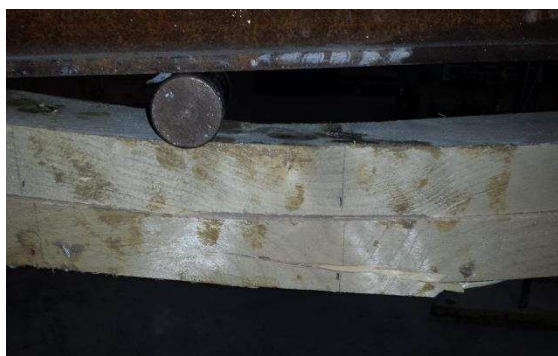
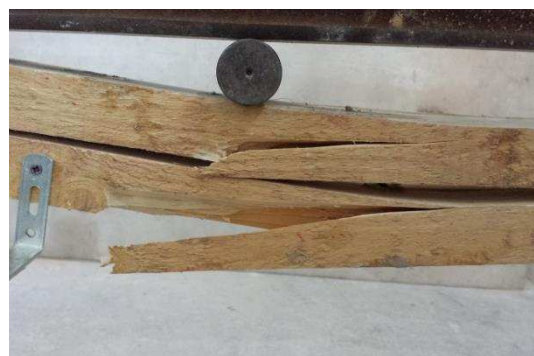
Figure 10. Timber tensile-flexural failures (cut in half beams): (a) in the lower half; (b) both in the lower and upper half.
