Citation: Tziviloglou, Eirini, Wiktor, Virginie, Wang, Jianyun, Paine, Kevin, Alazhari, Mohamed, Richardson, Alan, Gueguen, Marielle, De Belie, Nele, Schlangen, Erik and Jonkers, Henk (2016) Evaluation of experimental methodology to assess the sealing efficiency of bacteria based self healing concrete: Round robin test. In: RILEM Conference on Microorganisms – Cementitious Materials Interactions, 23 June 2016, Delft.

EVALUATION OF EXPERIMENTAL METHODOLOGY TO ASSESS THE SEALING EFFICIENCY OF BACTERIA-BASED SELF-HEALING MORTAR : ROUND ROBIN TEST

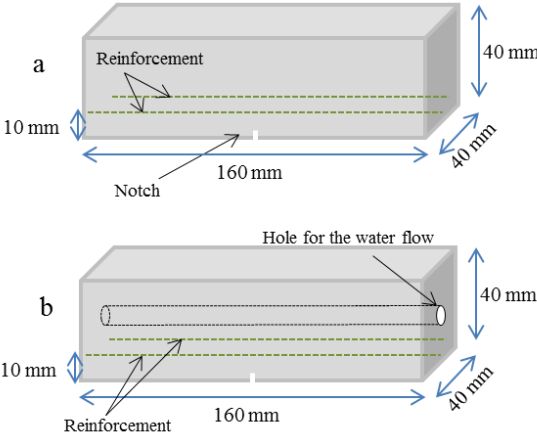
Figure 2. Typical prism: (a) for water absorption test and (b) for water flow test. Table 2 presents the number of specimens that were used per test in each laboratory.

For material characterization of the hardened mortar, prisms (40 mm x 40 mm x 160 mm) were cast in accordance with EN 196-1 [2]. For the water absorption test, reinforced (two steel wires $\phi 1$ mm) mortar prisms (40 mm x 40 mm x 160 mm) were cast (Figure 2a). For the water flow test, reinforced (two steel wires $\phi 1$ mm) mortar prisms (40 mm x 40 mm x 160

mm) with a 5-mm diameter cylindrical hole in the centre were used (Figure 2b). A notch of approximately 2-3 mm deep was made in the middle of every reinforced prism at the age of 28 days.

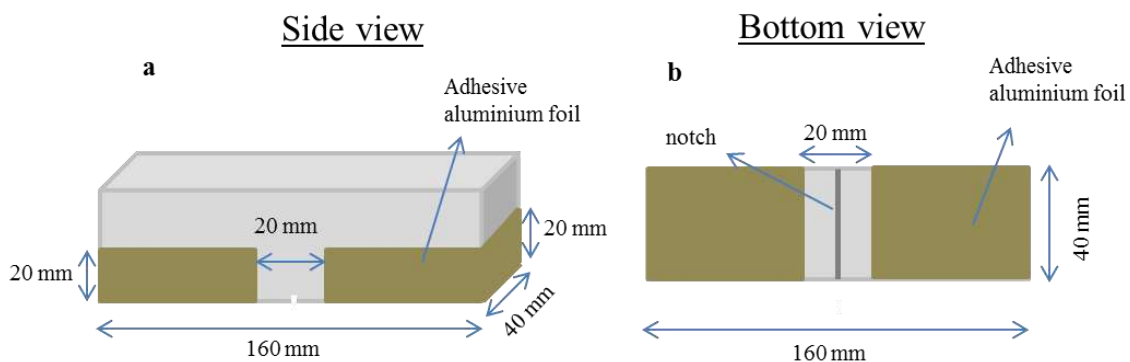
Figure 3. Water proofed specimen prepared for water absorption test: a) side view, b)bottom view.

Furthermore, another test was developed to investigate the ability of a cracked and healed specimen to absorb water. The procedure was based on the test described in EN 13057 [3]. During the test, the bottom of the specimens (the side with the notch) came into contact with water. The method used reinforced prismatic mortar specimens; non-cracked, cracked non-healed and cracked healed. Before testing, the specimens were kept at 40 °C for minimum 7 days, until a stable weight change was achieved. Then, the specimens were stored for 24h at 20 °C with 60 % relative humidity for one day. The specimens were weighed prior to the test. The test was carried out in a container and the specimens were standing on spacers, so that there was a gap between them and the bottom of the container. The water level in the container exceeded the bottom of the specimens by approximately 2-3 mm. Before the test, the specimens were partially waterproofed (with aluminium adhesive foil), as seen in Figure 3.

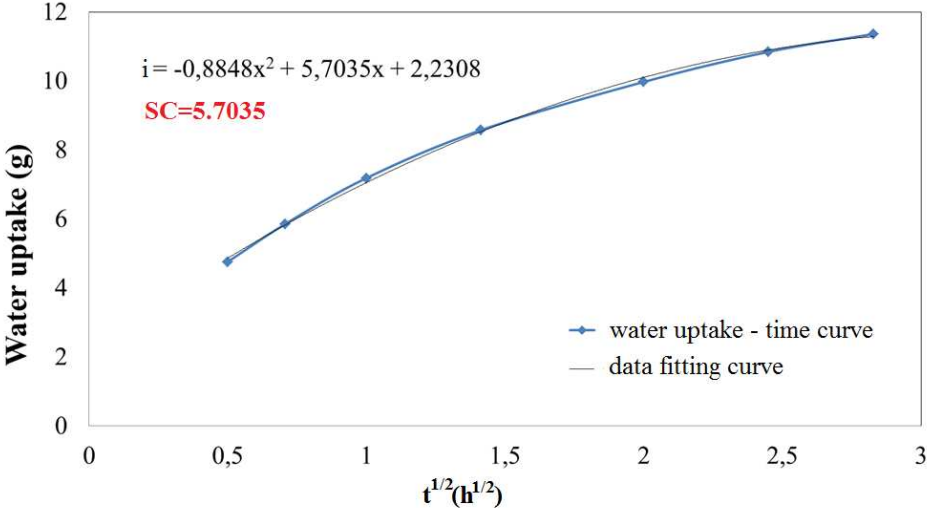
Figure 4. Typical graph obtained during water absorption test and polynomial data fitting curve.

Where i : the water uptake in g; t : time in h; SC : the sorption coefficient in $gh^{-1/2}$ and A and B are constant. A typical curve that can be obtained during water absorption test is shown in Figure 4. After the completion of the test, the average SC (out of three specimens) of each specimens category (non-cracked, cracked non-healed and cracked healed) was calculated in order to compare the absorption capacity of each category.

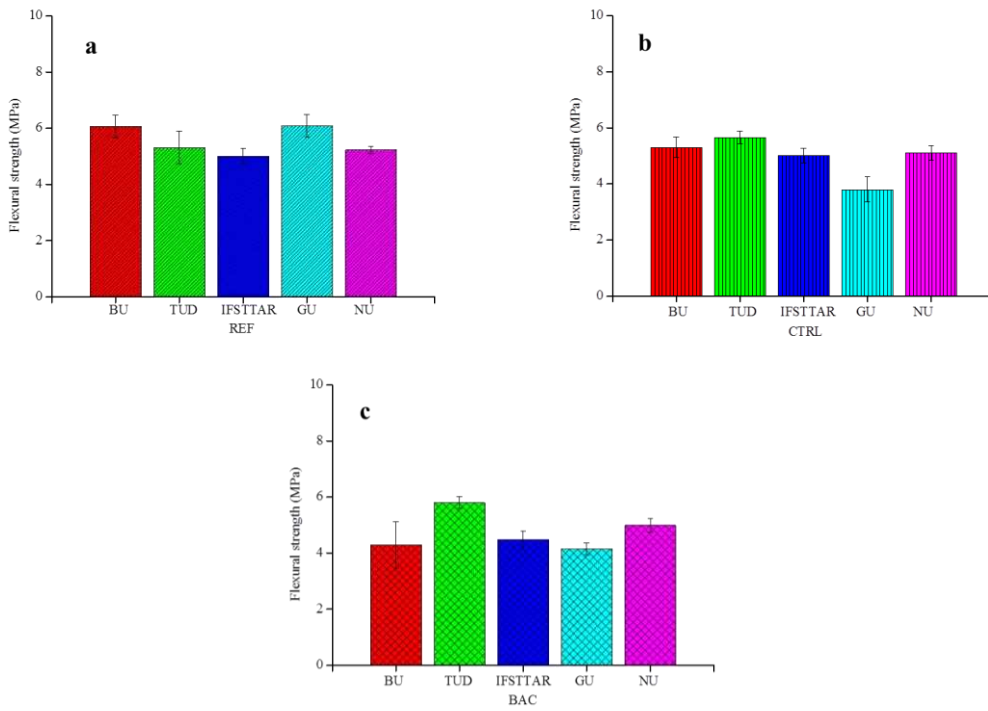
Figure 5. Flexural strength test results: a) REF specimens, b) CTRL specimens and c) BAC specimens.

The flexural strength results revealed that there was no significant difference among the three mixtures. In fact, most of the flexural strength values obtained varied between 4.5 and 6 MPa. In addition, not only the values obtained within each laboratory showed relatively low scatter but also the inter-lab variations were insignificant in view of observed standard deviations.

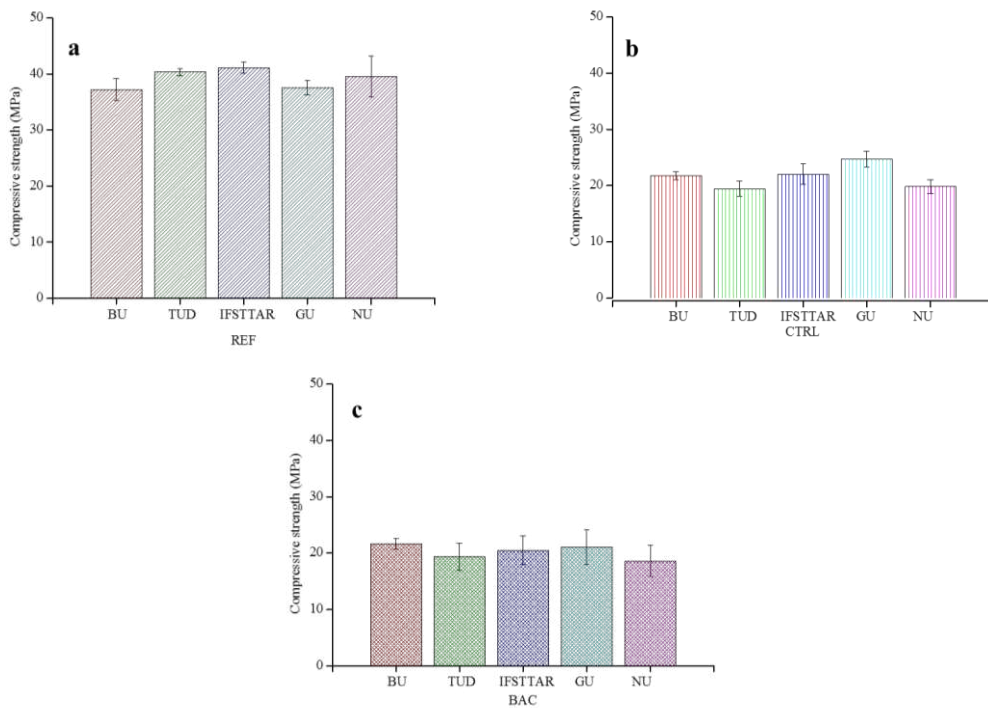
Figure 6. Compressive strength test results: a) REF specimens, b) CTRL specimens and c) BAC specimens.

The compressive strength results show the effect of the replacement of normal weight sand with LWA. Actually, the compressive strength of REF mixture on average was approximately 39 MPa, while CTRL and BAC specimens showed a reduction of almost 50%. However, the intra- as well as the inter-lab scatter was also relatively low.

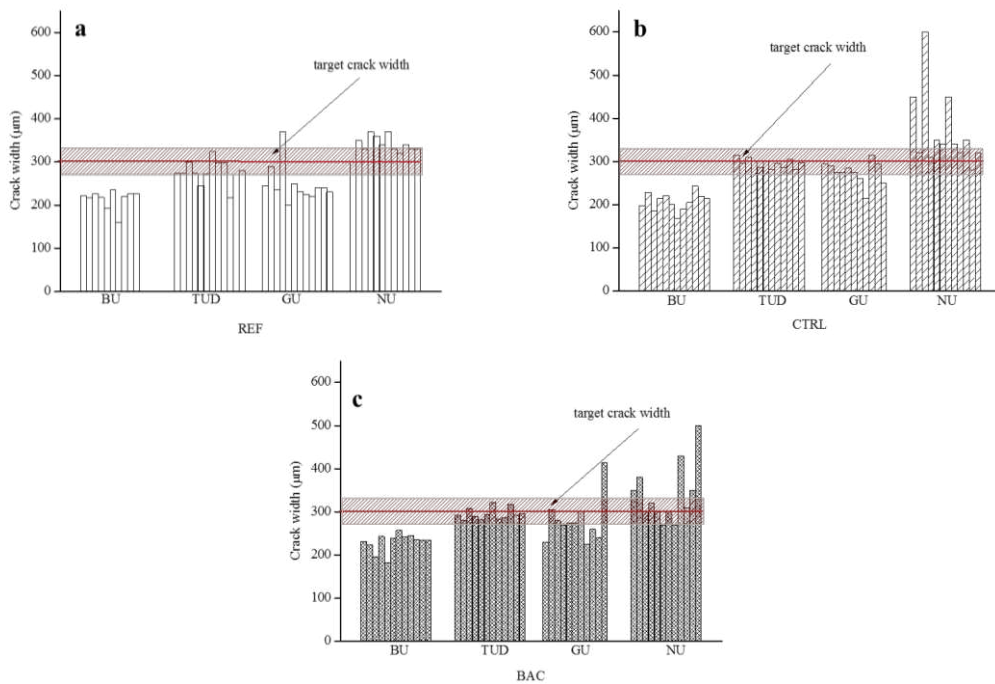
Figure 7. Crack width values after unloading: a) REF specimens, b) CTRL specimens and c) BAC specimens.

The intra-lab variation regarding the crack width values was relatively low, regardless the proximity to the target crack width value (300 μm). However, there was a high scatter of the results of the different participants, even within the same mixture. The differences in crack width values among the laboratories can be attributed to several reasons that are listed below:

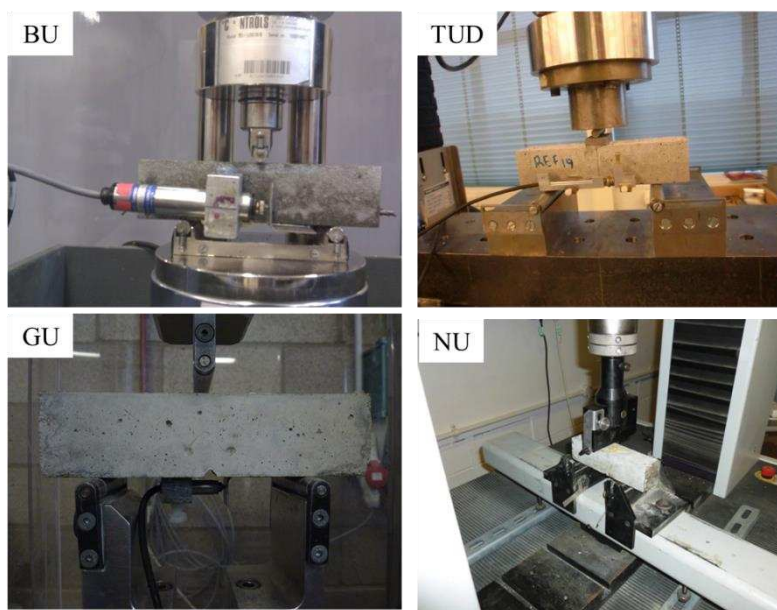
Figure 8. Set-ups of the different laboratories for crack introduction via 3-point-bending.

- The microscopic measuring method of the crack width differed for each laboratory.
- The crack width was controlled for TUD, GU and BU via LVDT sensors. However, the number of sensors and the position on the specimen varied. For example:
 - a. BU used one sensor on the front of the specimen.
 - b. TUD used two sensors on the front and back of the specimen,
 - c. GU used one sensor on the bottom of the specimen and
 - d. NU monitored indirectly the crack width; by conversion of the vertical displacement of the machine to the horizontal crack opening.

Even though every laboratory was targeting the same crack width, either the measuring position or the crack monitoring method were different. As a result, the average microscopic measurements among the laboratories was expected to show a high scatter.

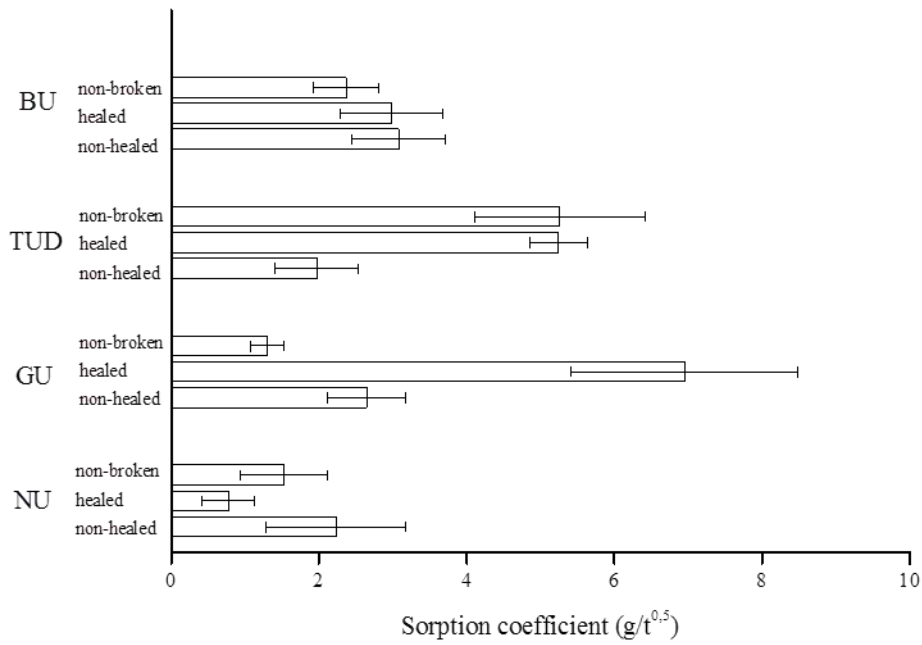
Figure 9. Average SC calculated from water absorption test - REF specimens.

The figures that follow (Figures 9,10 and 11) present the average sorption coefficient of each mix category (out of three replicates) calculated as seen in 3.3.

The results of the water absorption test revealed a very random behaviour for all categories of specimens (REF, CTRL and BAC). In fact, the results showed:

- a relatively high standard deviation within the measurements of each individual laboratory,
- no clear trend in the values of sorption coefficient; for example $SC_{\text{non-healed}} > SC_{\text{healed}} > SC_{\text{non-broken}}$

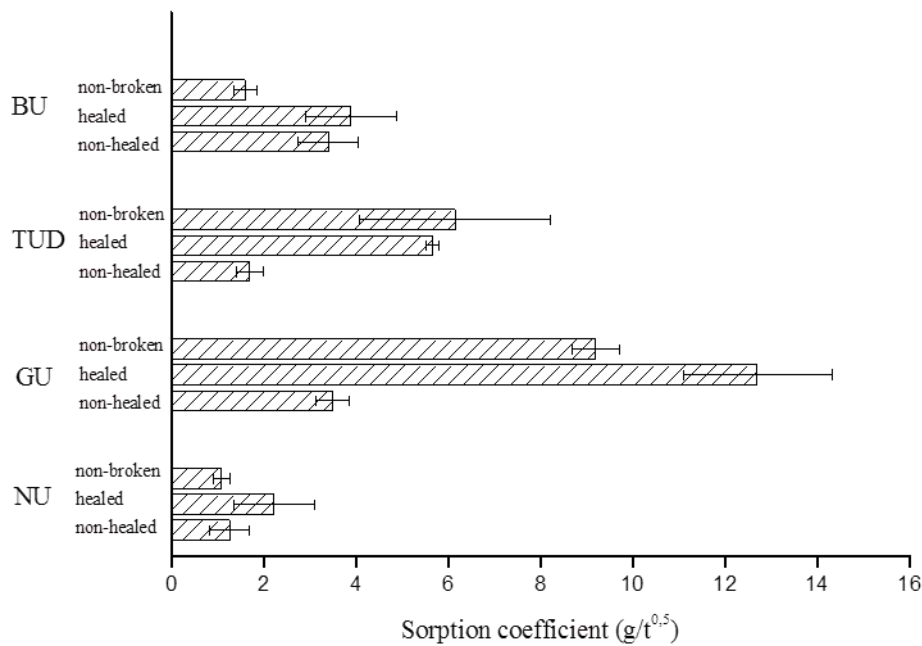
Figure 10. Average SC calculated from water absorption test - CTRL specimens.

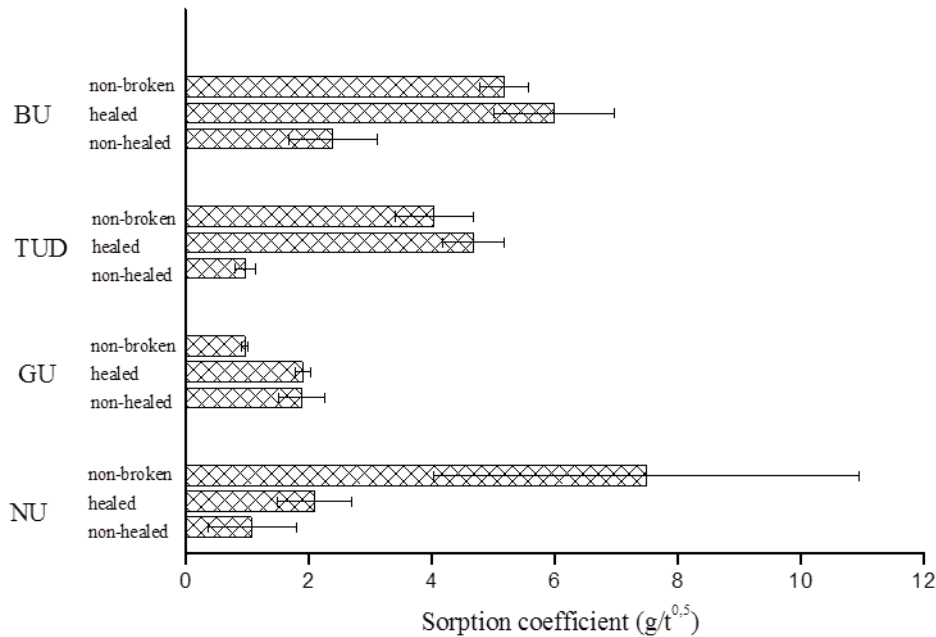
Figure 11. Average SC calculated from water absorption test - BAC specimens.

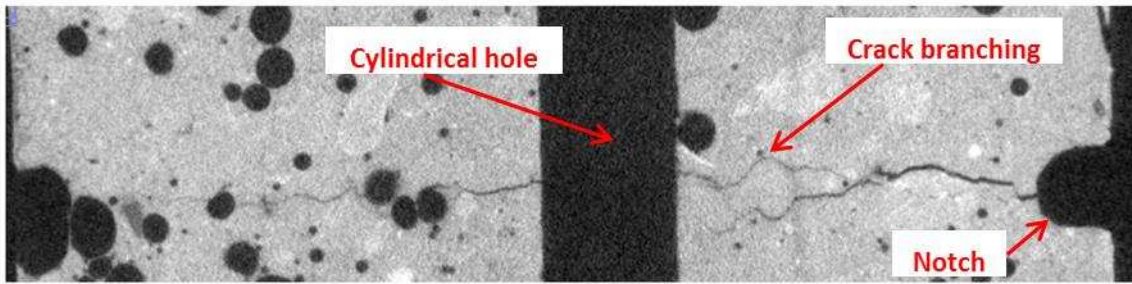
Figure 12. Computed Tomography (CT) image on a cracked mortar specimen with cylindrical hole showing crack branching

Moreover, it was observed that the crack shapes/geometries were very often different even in intra-lab level. In some cases, there was also crack branching (Figure 12) at a height of some millimetres over the notches. The differences in the cracks can be explained by :

- The presence of the notch in every specimen. The notches were manually introduced and were supposed to have a 2-3 mm depth. However, it was hard to achieve the exact constant depth along the width of the sample. Furthermore, the method of introducing the notch as well as its width and shape varied among the laboratories.
- The type of the reinforcement. The two steel reinforcing wires that were used were quite flexible. Thus, the reinforcement resembled more to a curved/corrugated wire rather than a straight steel bar. As a consequence, the shape of the reinforcement varied for every sample that was cast.
